Running Head: VINYL SIDING FIRES

The Wall of Fire:  
Training Firefighters to Survive Fires in Vinyl-Clad Houses

Anthony E. McDowell  
Henrico County Division of Fire  
Richmond, VA

September 2009

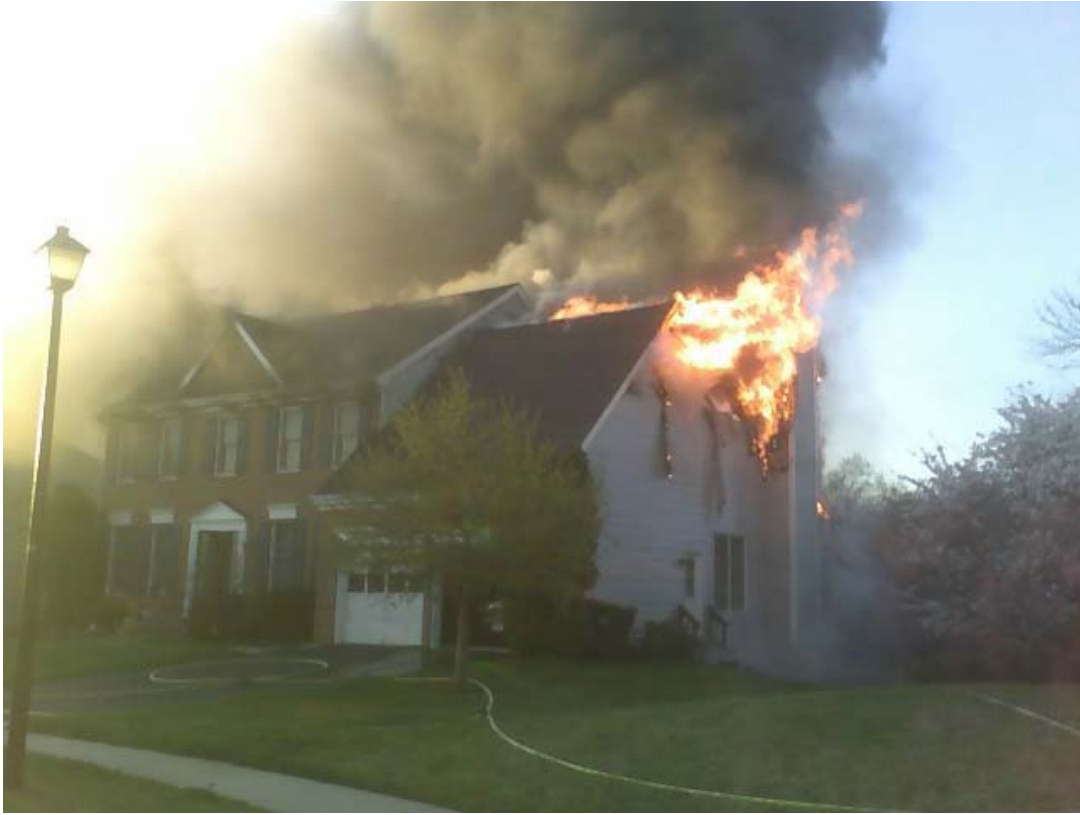
*Figure 1. 4909 Fox Creek Court*

In the early evening of April 3, 2007, Fairfax County (VA) Engine 415 responded for a motorcycle fire under a deck at a large vinyl-clad house (FCFRD, 2008). When the engine arrived on scene, they observed fire burning from rear deck, up the vinyl siding, and extending into the attic. The firefighters extinguished the visible fire on the outside before proceeding into the house through the front door, advancing their hose to the second floor. From the second floor landing, they were attempting to create an opening in the ceiling when “an explosion occurred, forcing one member over the railing and the other two members down the stairs to the first floor” (FCFRD, 2008, p. 3). The three firefighters were taken to the hospital, and the house suffered significant damage. The subsequent investigation revealed that “the fire, fueled by vinyl siding, extended into the attic through the soffit . . . fire gasses and carbon monoxide levels increased in this attic space. The levels reached explosive range and the gas ignited, causing the explosion” (p. 8). Figure 1 is a photo that shows the vinyl siding melting, sagging and burning, as fire approaches and enters the attic through the soffits and gable vents.

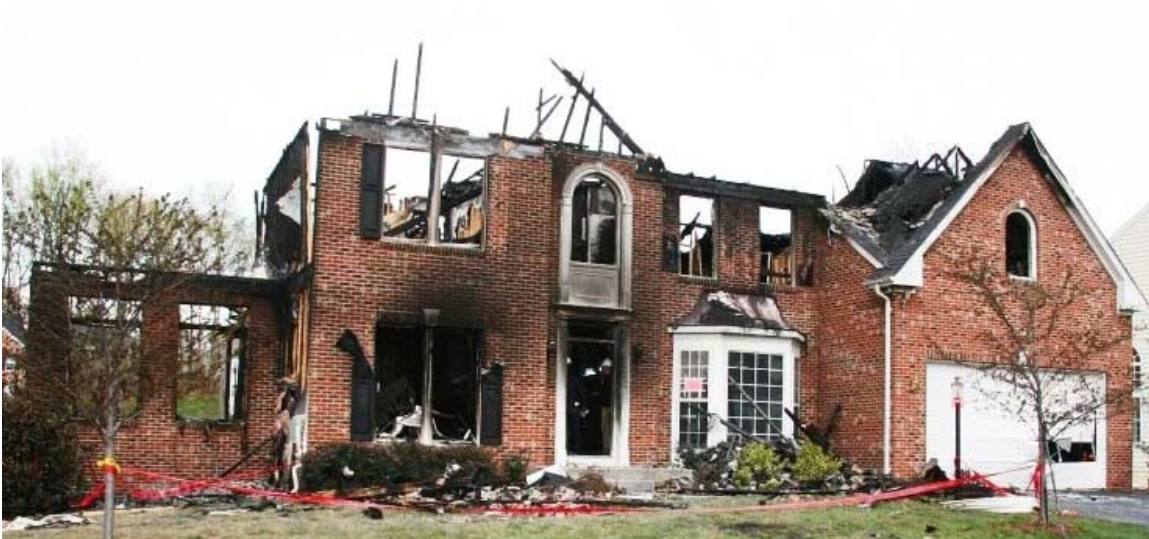
*Figure 2. 15474 Marsh Overlook*

After the incident, the department conducted an in-depth investigative report. While a number of issues were determined through this investigation, according to Fire Chief Kevin McGee, “two major issues rose to the top” (PWCFR, 2007, p. 2). The first was the impact of wind on fire conditions. During the incident, sustained winds accelerated the exterior fire growth and contributed to the spread of fire into and through the house. The second issue related to the role that vinyl siding played. Chief McGee writes:

Figure 2 is a photo of the house in which Firefighter Wilson died. This photo shows how the vinyl siding on three sides of the house was consumed, leaving only the brick veneer on the front intact.

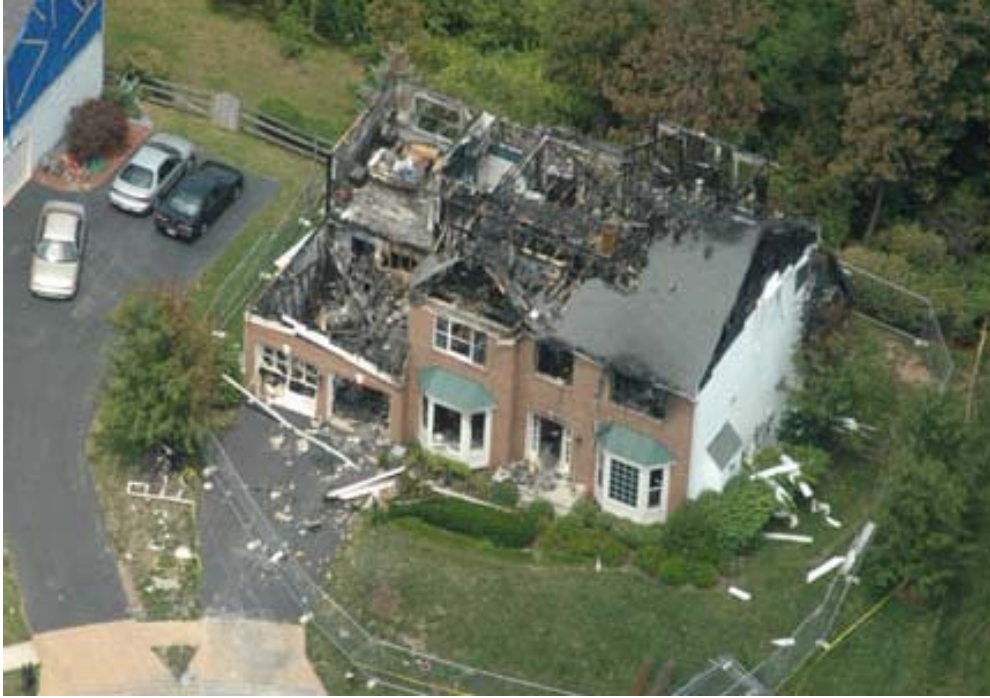
*Figure 3. 43238 Meadowood Court*

In the investigation that ensued, Loudon County Fire Chief Joseph Pozzo concluded that “the challenge of rapid fire spread is exacerbated by the use of lightweight roof trusses, vinyl siding, and combustible sheathing” (LCDFR, 2008, p. 3). The report went on to specifically discuss the role played by vinyl siding, “the construction features and building materials, in particular the vinyl siding and combustible sheathing, contributed to the rapid spread of the fire” (p. 43). In a now too-familiar pattern, the report noted, “fire spread along the vinyl siding and combustible sheathing and traveled up through the vented soffits into the continuous attic space” (p. 88).

Figure 3 shows an aerial image of the house after the fire. The pattern of vinyl-clad walls consumed, and the roof burned away, is similar to the other case studies.

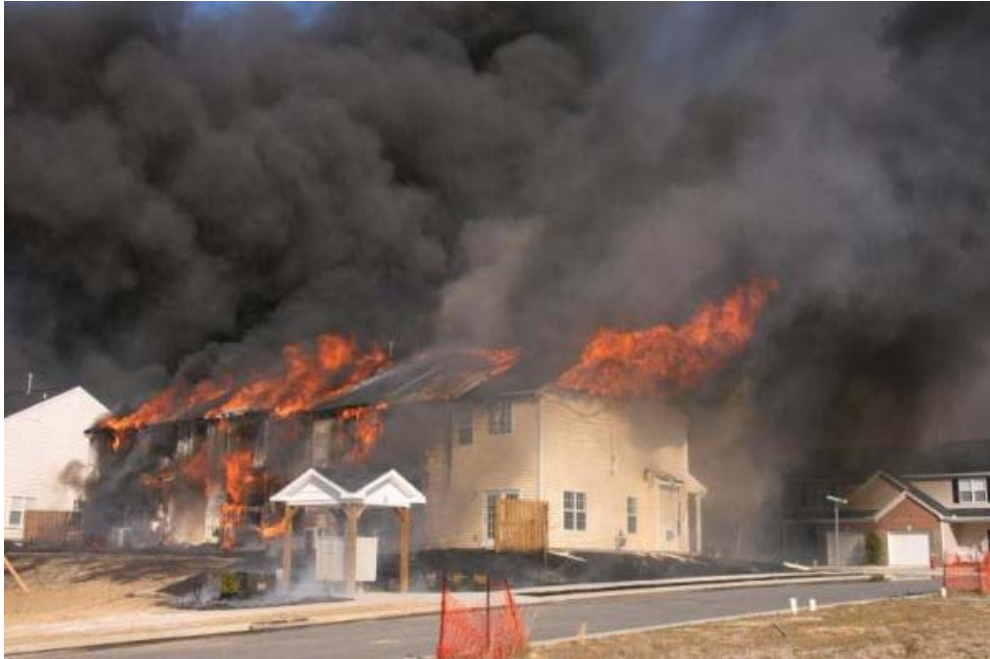
*Figure 4. Pine Knoll Townhome Fire*

On February 22, 2007, a fast-moving fire destroyed 32 townhomes in the Pine Knoll Townhomes subdivision in Raleigh, North Carolina. A grass fire, fanned by strong winds, quickly ignited the vinyl siding of one townhouse. The fire quickly extended up the vinyl siding, entering the attic through the vinyl soffits (Bossert, 2007). Since the fire was on the exterior of the structures, the fire-rated walls that separated the units failed to stop the spread of fire from unit to unit. As burning brands issued into the sky and fell on neighboring properties, the size of the fire quickly grew (Bossert, 2007).

After the fire, the City of Raleigh hired an independent professional engineering firm to evaluate the causes of the fire. The report concluded that “the effect of combustible soffits was a major influence to fire spread . . . vinyl soffits melted and exposed combustible attics” (Bossert, p. i). The report continues on to note that “once

fire entered the attics, the roof shielded firefighting efforts, and the units were consumed” (p. 19). As a direct result of this incident, on April 5, 2007, the North Carolina Building Code Council issued an emergency rule change to the residential code, requiring “non-combustible materials for soffit construction” (Bossert, 2007, p. 22).
