Executive Analysis of Fire Service Operations in Emergency Management

Analysis of Mixed-use Occupancy Target Hazards in Uptown Shelby North Carolina

William P. Hunt

Shelby Fire & Rescue Department

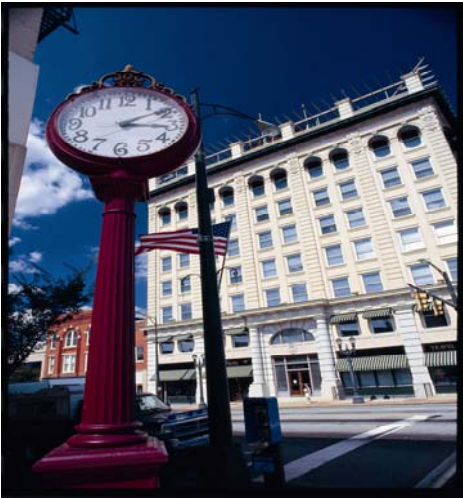
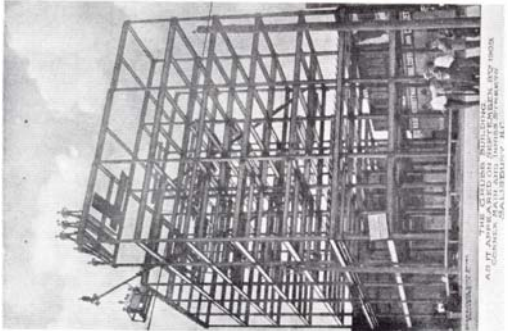
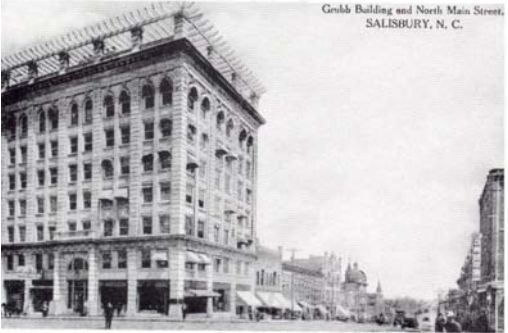
The Plaza, Salisbury, North Carolina

The case study analysis of The Plaza (Appendix B) found the building to be of substantial construction. The building is of fire resistive construction and features a substructure of steel reinforced concrete columns and beams with a brick and limestone façade. The building is seven stories in height and has one below grade level. Interior walls are traditional plaster on wire lath. Upper floor window openings are common double hung and are operational. In the 1991 renovation, the building was divided by occupancy by fire walls and distance separation into three distinct zones. The street level is dedicated to commercial/retail, the second for office space and, floors three through seven are reserved for residential occupancy.

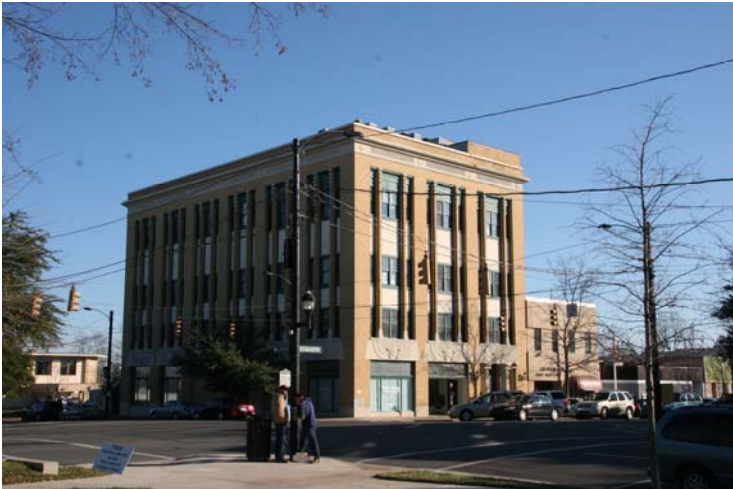
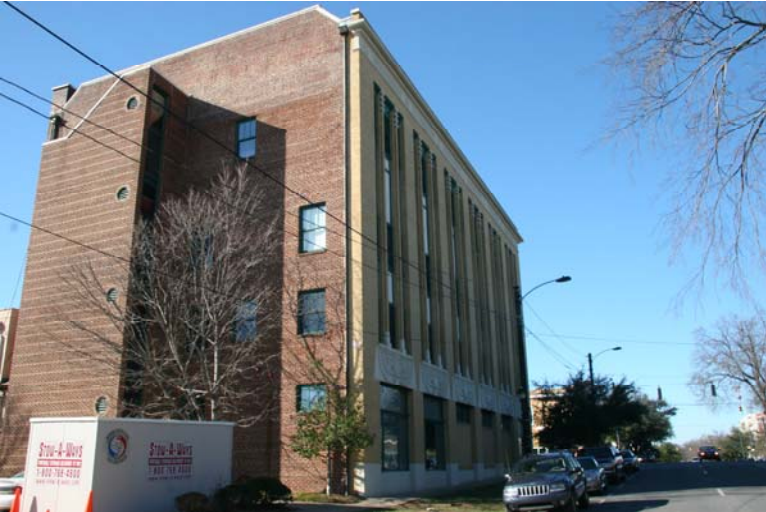
Mason Square, 208 South Washington Street

The construction features of Mason Square (Appendix E) include a steel frame substructure with a brick and limestone exterior. The building is four stories in height and has a partial basement for services. A rooftop penthouse houses elevator mechanicals and the rooftop contains HVAC units. The interior walls are a mix between traditional wire lath and plaster, and, modern gypsum wallboard. Upper floor window openings are modern double hung sash replacements and are fully operational.

The occupancy hazards presenting at this property are similar to those cited in the case studies. Currently the ground floor consists of six office suites and the second floor is devoted to one tenant space. Moving people from the sixteen residential units on the upper floors to the outside ground level in the event of an emergency seems to be the most prominent hazard.

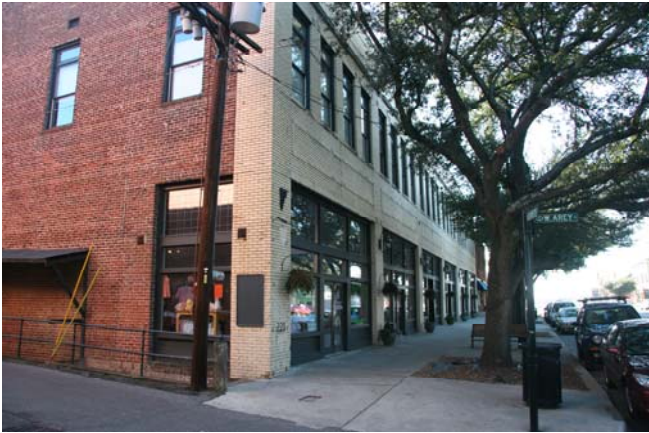
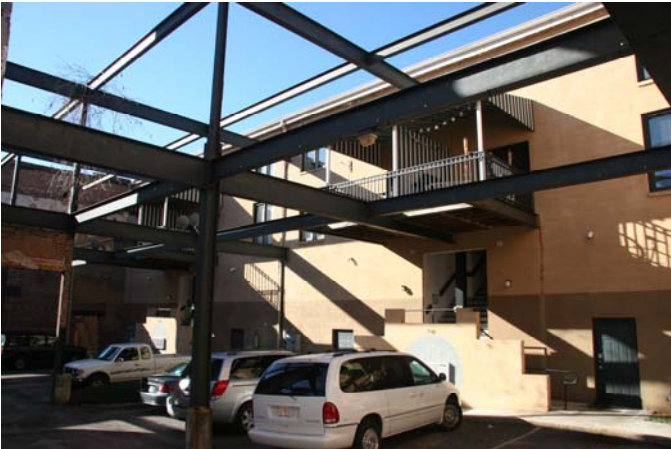
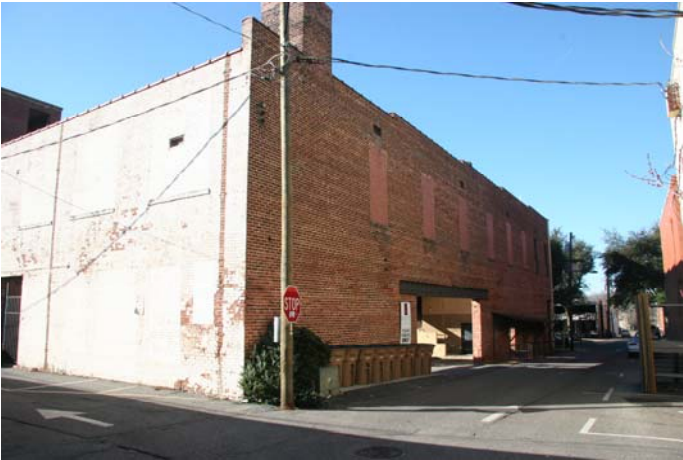
Lafayette Place, 200 South Lafayette Street

The primary occupancy hazard in Lafayette Place lies in the ability of residential occupants to escape in the event of a fire. As already noted, egress from any of the individual condominiums is limited to one route. The only alternative in the event a stairway is compromised by a fire or other crisis is by the street front windows. There is negligible hazard from the current commercial/retail tenants on the first floor. However, a large restaurant located in the building next door to Lafayette Place is a potential hazard since the integrity of the fire wall between the two buildings cannot be confirmed. Finally, the site visit revealed weakness in the wall systems in the form of cracks and evidence of past repair to the masonry walls.

Fire department operations in this building present significant challenges. Although a network of alleys surrounds the building, access to the building is limited. The alley network is narrow and within the collapse zone of the building which hinders any fire department operations from the rear of the building, and, given the overall condition of the masonry walls, early collapse should be suspected. Compounding this problem is the normal access to the residential units is at the rear of the building.

Further, aerial ladder access from the front is hindered by several mature live oak trees lining the street. These conditions limit ready access by fire apparatus and personnel.

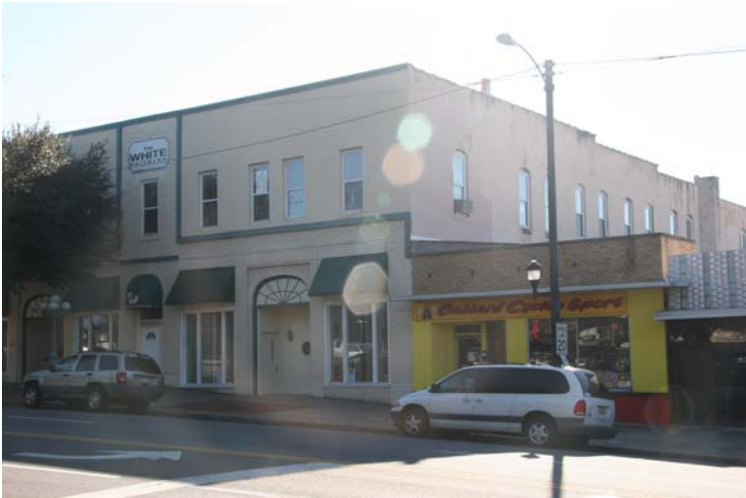
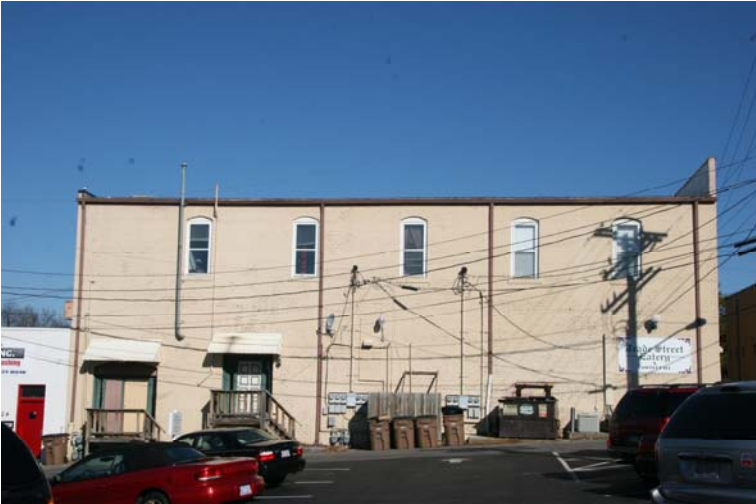
The White Building, 119 East Marion Street

The site visit of the property found that hazards specifically related to non-residential occupancy are limited since all of the tenants are of an office type occupancy. This leaves the major occupant hazard as the ability of residential occupants to effectively escape during a fire or other crisis. The major problem hindering evacuation is the integrity of the front stairway. Since it is unprotected, a significant hazard potential exists in that it can be easily compromised in a fire situation thus leaving the only other means of escape through the rear stair way exit. A paint store located next door to the study property poses a proximal risk.

With regard to fire department operations significant tactical consideration must be given to life safety of the residential occupants and toward the structural integrity of the building. As already noted, the front stair way leading to the second floor is unprotected. A fire in the first floor tenant space near the stair channel can compromise the stairway, thus making evacuation from the front impossible. Further, the operations of fire crews will be hampered as they will be forced utilize the same route for access as the occupants are using for egress. Considering structural integrity, in light of the deteriorated masonry, breached fire separations, and the significant

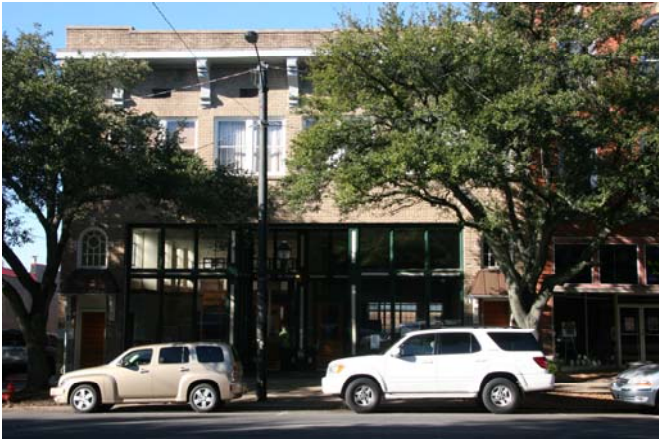
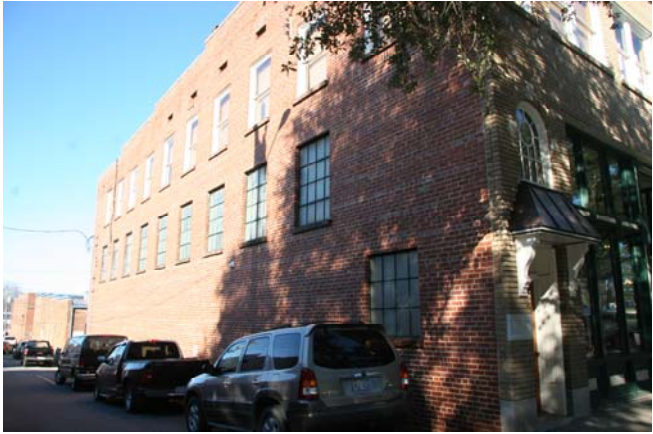
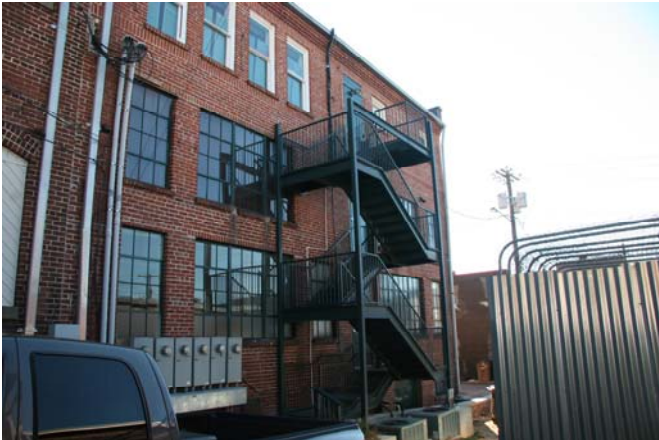
The Eifirds Building, 214 South Lafayette Street

The Eifirds Building (Appendix H) is of ordinary construction consisting of double-width brick exterior walls and wooden support columns and beams. Interior wall finishes are a combination of plaster on wire lath, and, modern gypsum wall board. The building is two and a half stories in height with a full basement. During the site visit it was noted that numerous steel beams and columns were installed for extra support. All of the steel members are unprotected. The building has a flat roof with a parapet. A modern bladder roof system has been laid over the original decking. Window openings are common casement style and are fully operational. The tenant space consists of two commercial/retail space on the first floor and seven residential apartments located on the second floor. A system of two-hour fire rated separations are used to subdivide the uses of the building by occupancy.

Much like the White Building, the main occupancy hazards within in the Eifird's Building originates from the non-commercial application. However, in this case the extensive rehabilitation of the property mitigates those hazards significantly. The combination of active fire protection from the sprinkler system and early warning from the fire alarm and detection system offers significant risk reduction benefits. Further, the compartmentalization by occupancy also works to reduce life hazard risks. Like the other study properties, there is a concern for evacuation, although residential tenants only have to travel one floor to street level, and, there are only seven residential units utilizing two egress paths.
